P.I.N. X051.59  
BRIDGE DECK EVALUATION REPORT

<u>Description:</u>	Grand Central Parkway over Winchester Blvd and Cross Island Parkway and Ramp "H" over Cross Island Parkway
<u>BIN:</u>	1065149 and 106514A
<u>GCP Reference Marker:</u>	1120 to 1124
<u>County:</u>	Queens
<u>City of:</u>	New York
<u>Region:</u>	11
<u>Feature Carried:</u>	Grand Central Parkway and GCP Ramp "H"
<u>Feature Crossed:</u>	Cross Island Parkway Winchester Blvd

# IN-DEPTH INSPECTION REPORT

**B.I.N. 1-06514-9 & 1-06514-A**

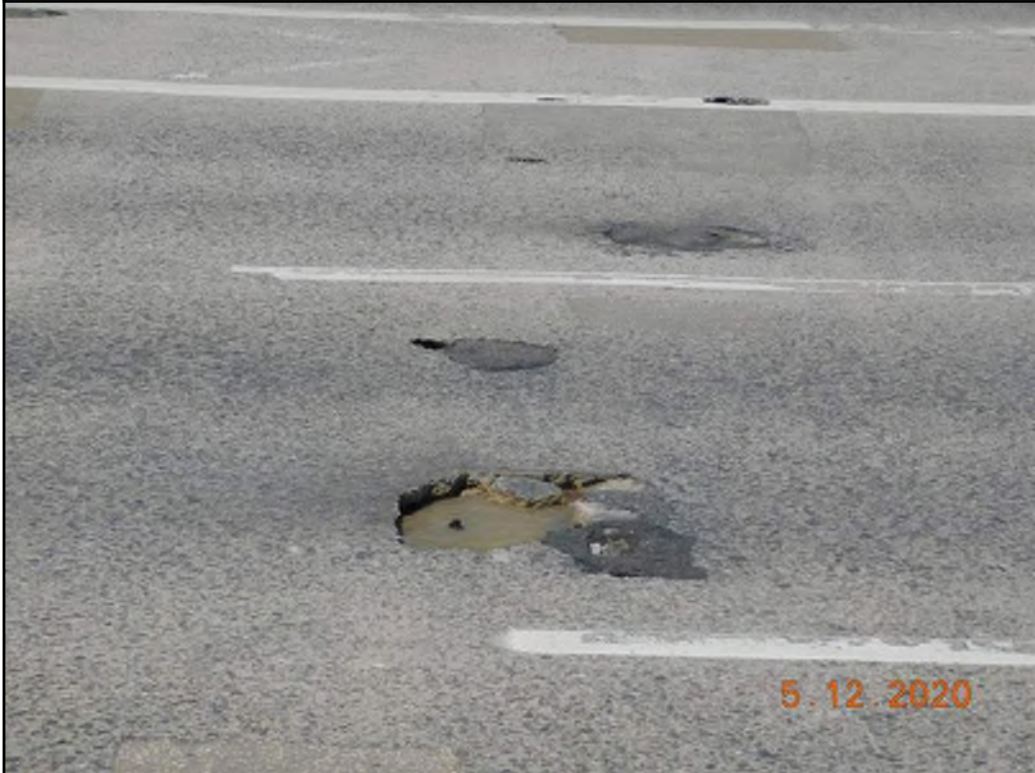
Photo Number: **41** Photo Filename: **20\_SW\_6078.JPG**

**Attachment Description:**  
Location: Span 7, W/B  
Wearing Surface; Looking  
Left. Potholes with water  
ponding and uneven asphalt  
patches. (Typical)

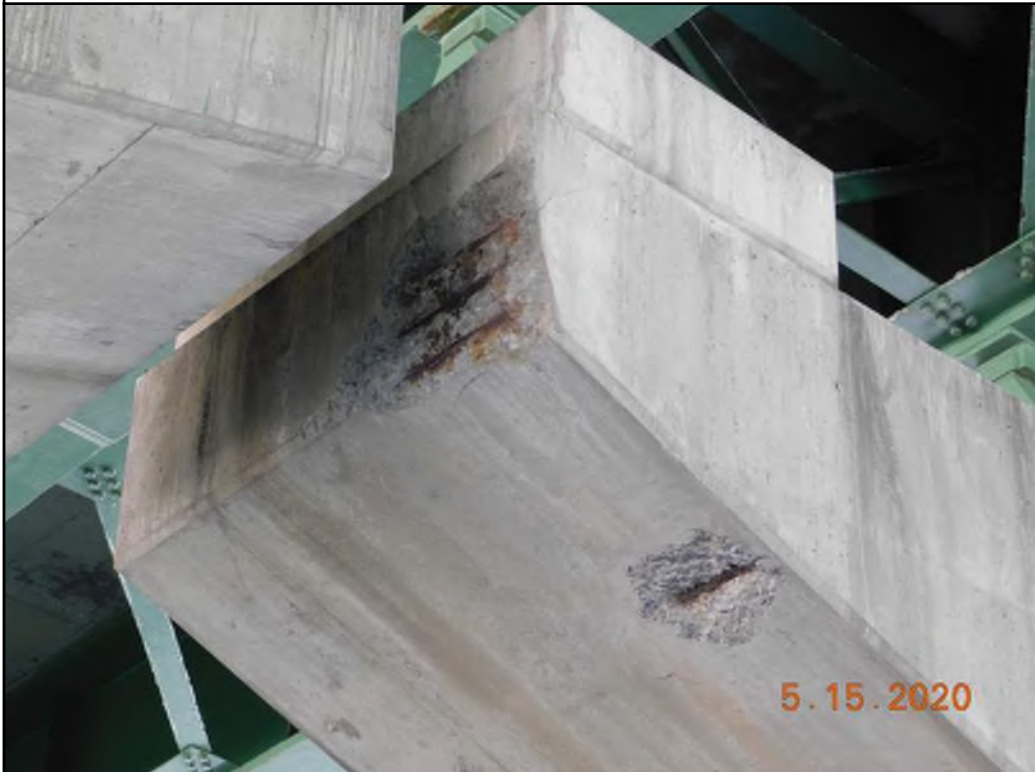
Photo Number: **42** Photo Filename: **20\_SW\_6127.JPG**

**Attachment Description:**  
Location: Pier 8, Pier Cap,  
Underside Girder G12;  
Looking Ahead and Right.  
Spalls with exposed rebar.

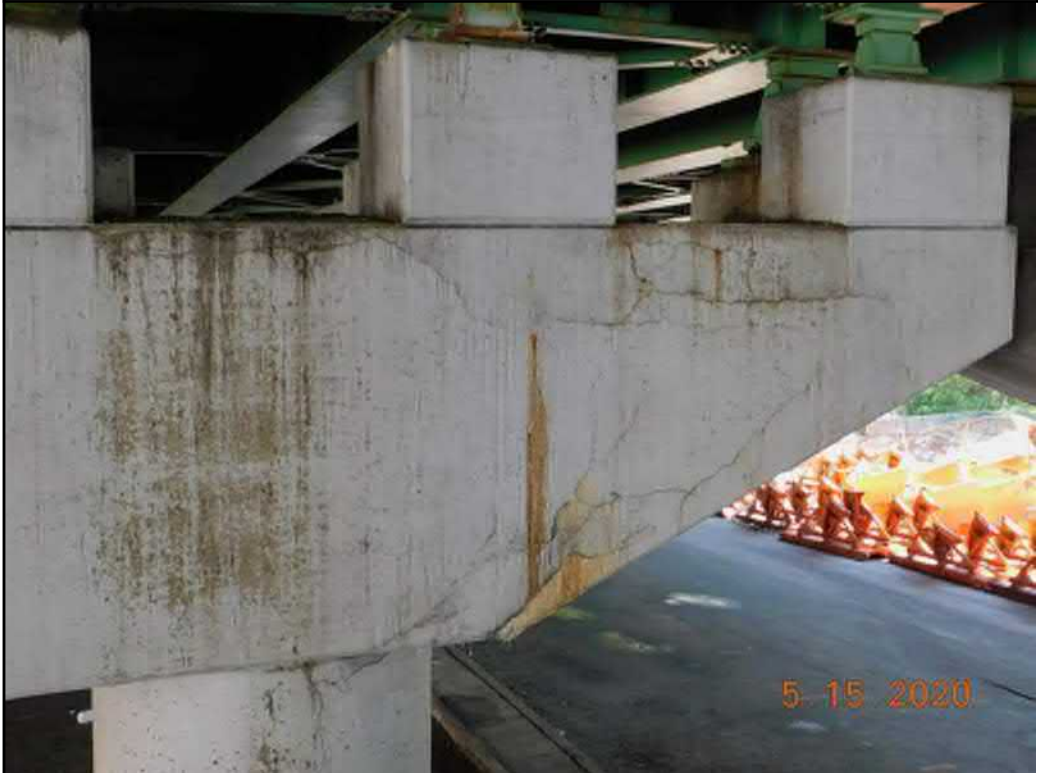
Photo Number: 43 Photo Filename: 20\_SW\_6113.JPG

**Attachment Description:**  
Location: Pier 9, Pier Cap,  
Begin Face under Bays 9-  
10; Looking Ahead.  
Scattered cracks.

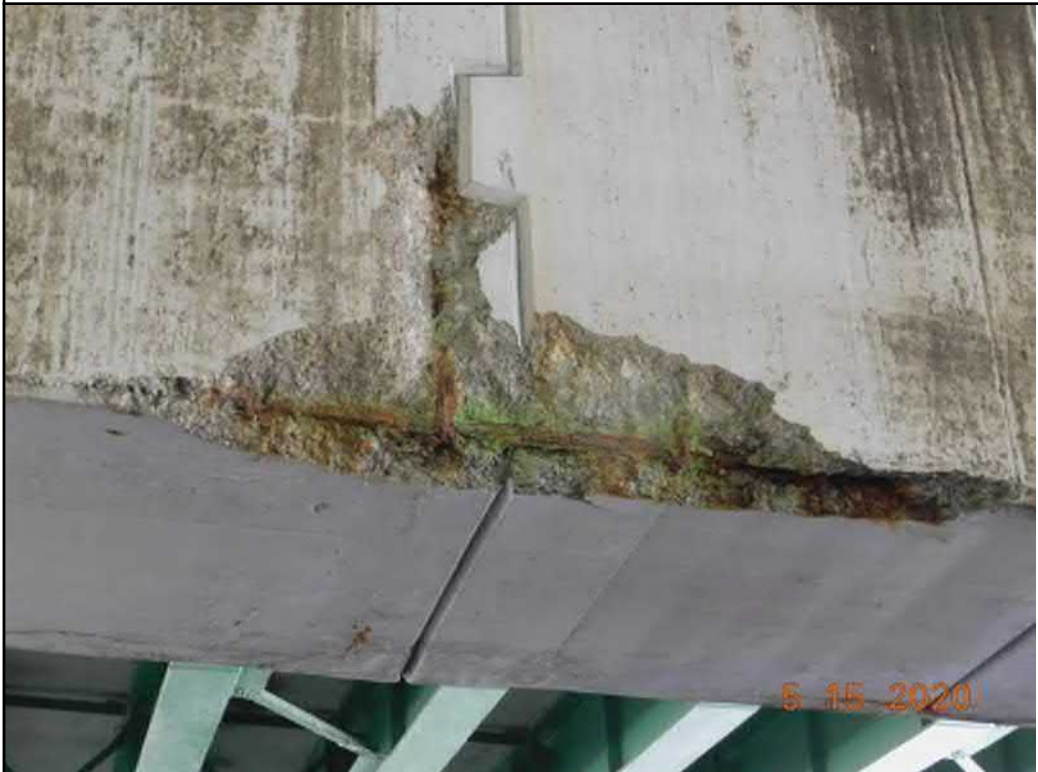
Photo Number: 44 Photo Filename: 20\_SW\_6128.JPG

**Attachment Description:**  
Location: Pier 9, Pier Cap,  
End Face under Girder  
G11; Looking Back. Spall  
with exposed main  
reinforcement.

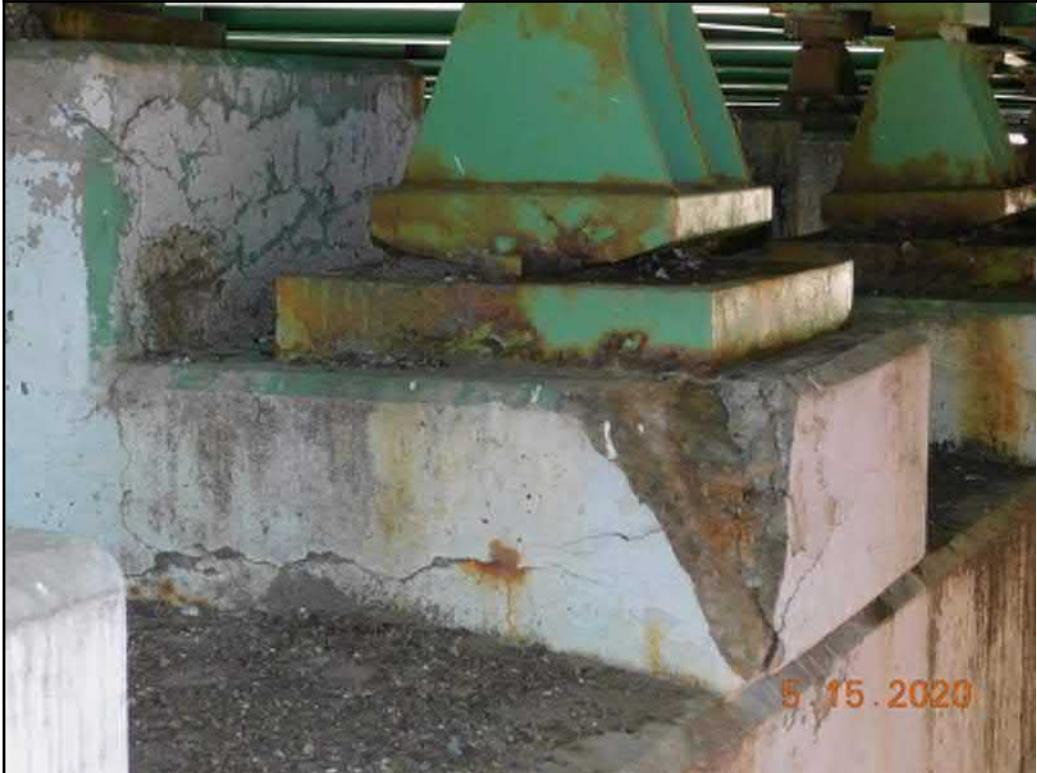
Photo Number: 45 Photo Filename: 20\_SW\_6116.JPG

**Attachment Description:**  
Location: Pier 9, Pedestal  
#21, Span 10 side; Looking  
Back and Left. Spall and  
cracking.

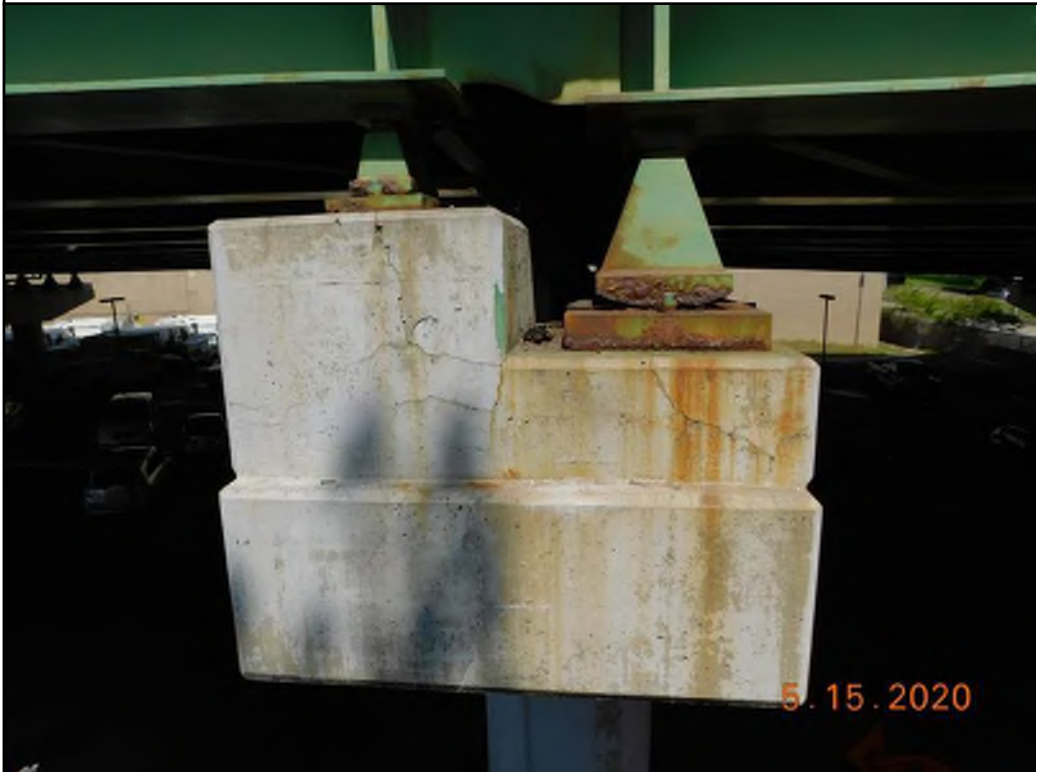
Photo Number: 46 Photo Filename: 20\_SW\_6117.JPG

**Attachment Description:**  
Location: Pier 9, Right Face  
Pedestals; Looking Left.  
Scattered pedestal cracks.

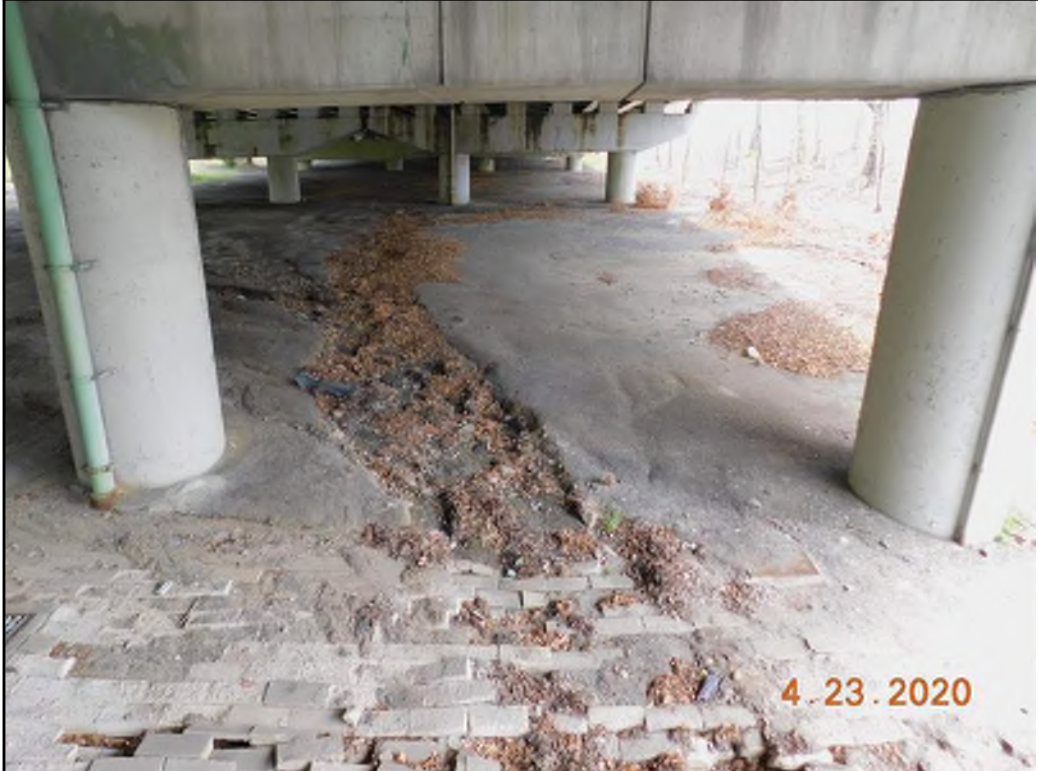
Photo Number: 47

Location: Pier 11 between Columns C3-C4; Looking Ahead. Erosion between columns.

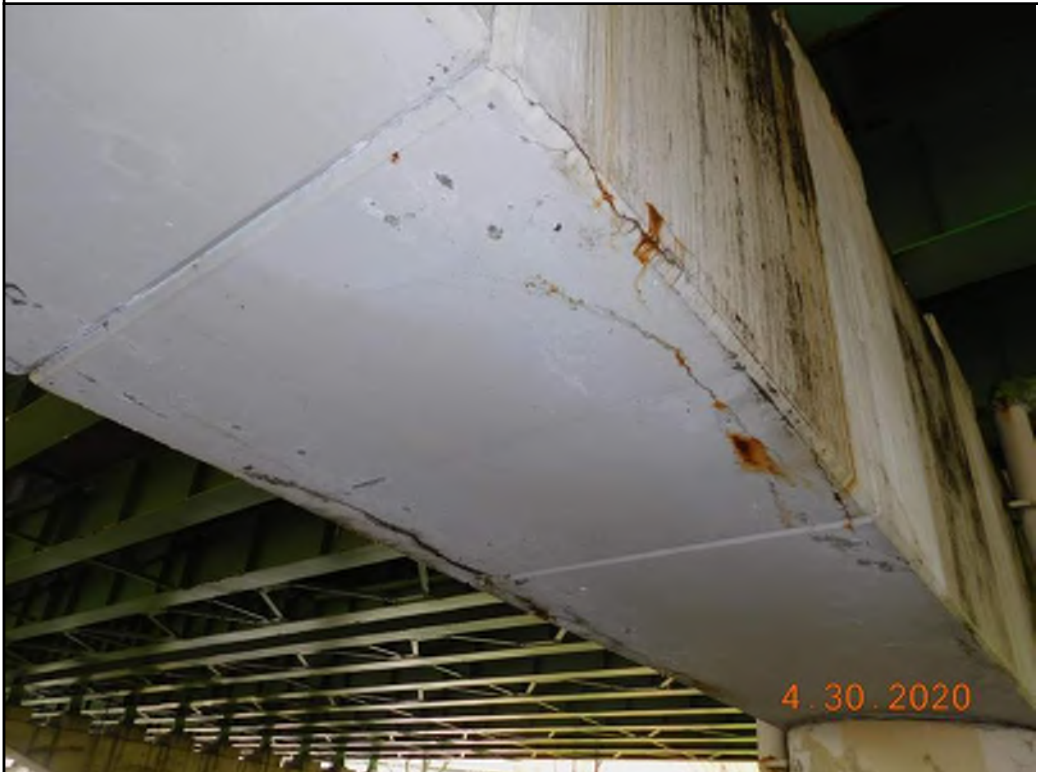
Photo Number: 48

Location: Pier 12, Right Pier Cap between C3 and C4, Underside; Looking Back and Left. Horizontal cracks with rust bleed.

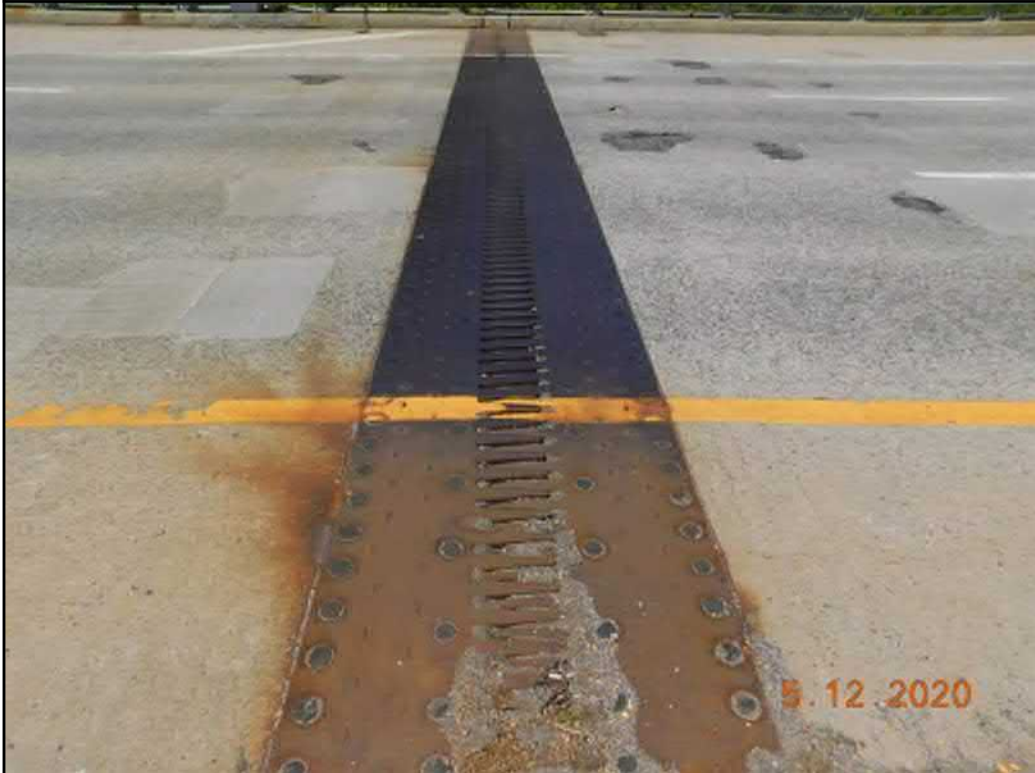
Photo Number: 49 Photo Filename: 20\_SW\_6088.JPG

**Attachment Description:**  
Location: Pier 12, E/B Joint  
near median; Looking Right.  
Joint filled with dirt and  
debris.

Pier 12 E/B (Typical)	N/A	Joint Description: Finger Plate Joint  Condition Code: 5. Debris Filled	CS3
Piers 6 & 9	E/B & W/B	-	-	N/A	Joint Description: Finger Plate Joint  1. Sealer appears to be functioning / sealed properly / not damaged	-

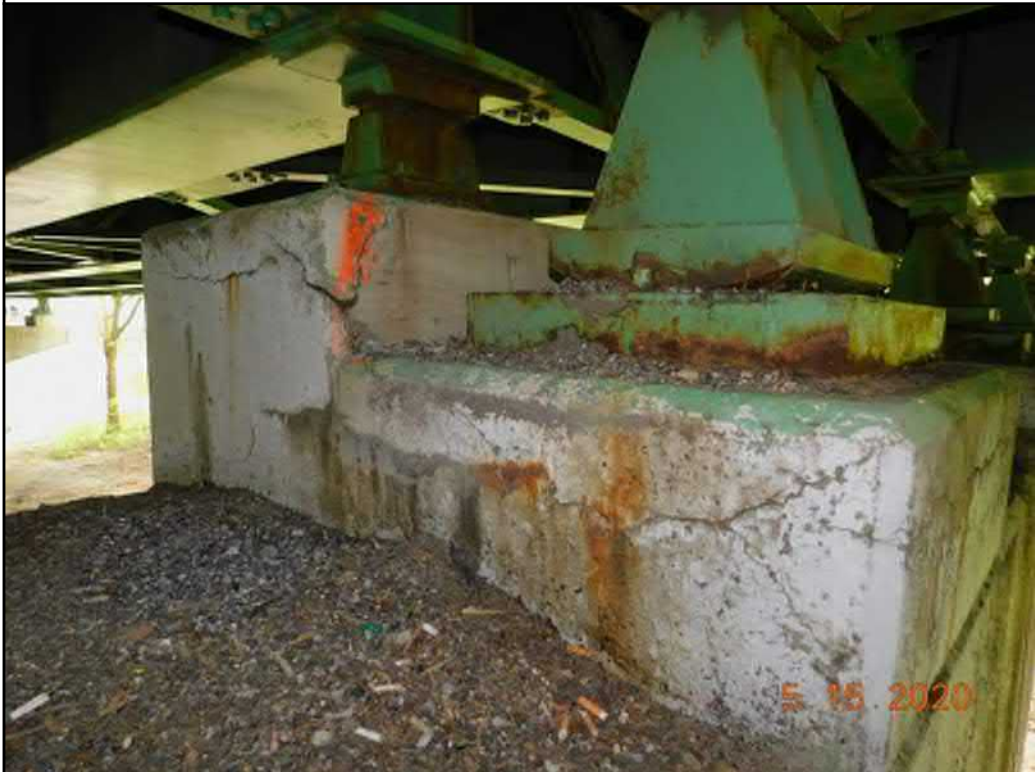
Photo Number: 50 Photo Filename: 20\_SW\_6131.JPG

**Attachment Description:**  
Location: Pier 12, Pedestal  
#4, Right Face; Looking  
Back and Left. Horizontal  
cracks.

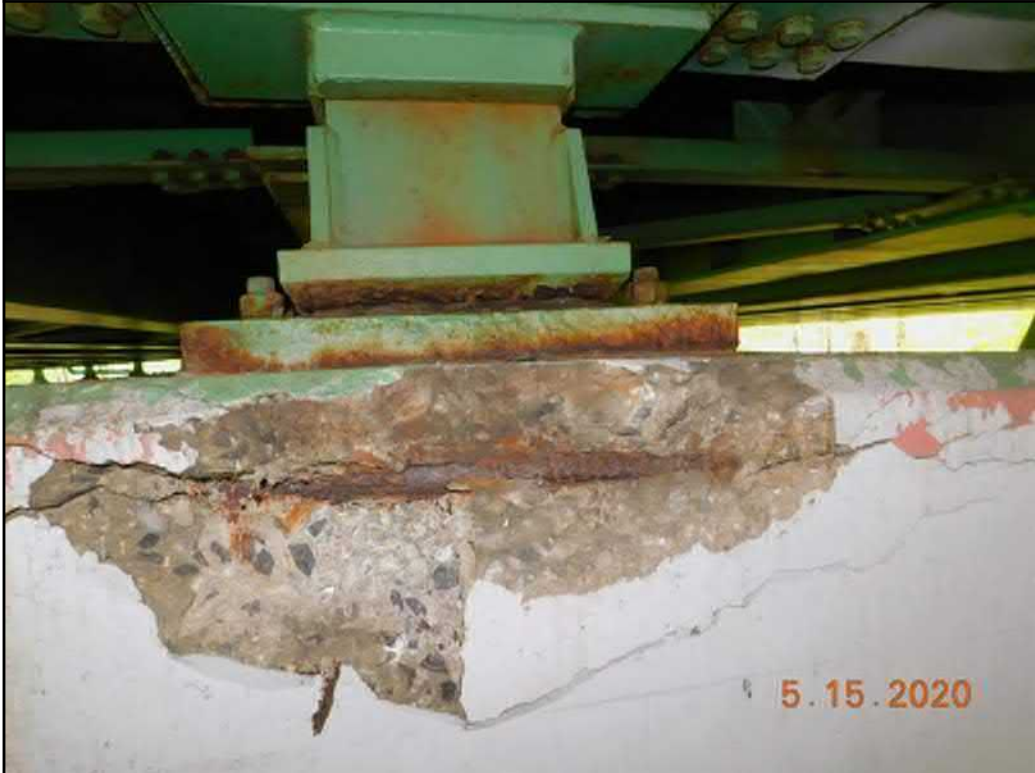
Photo Number: 51

Location: Pier 12, Pedestal #8, Span 12 side; Looking Ahead. Spall with exposed rebar.

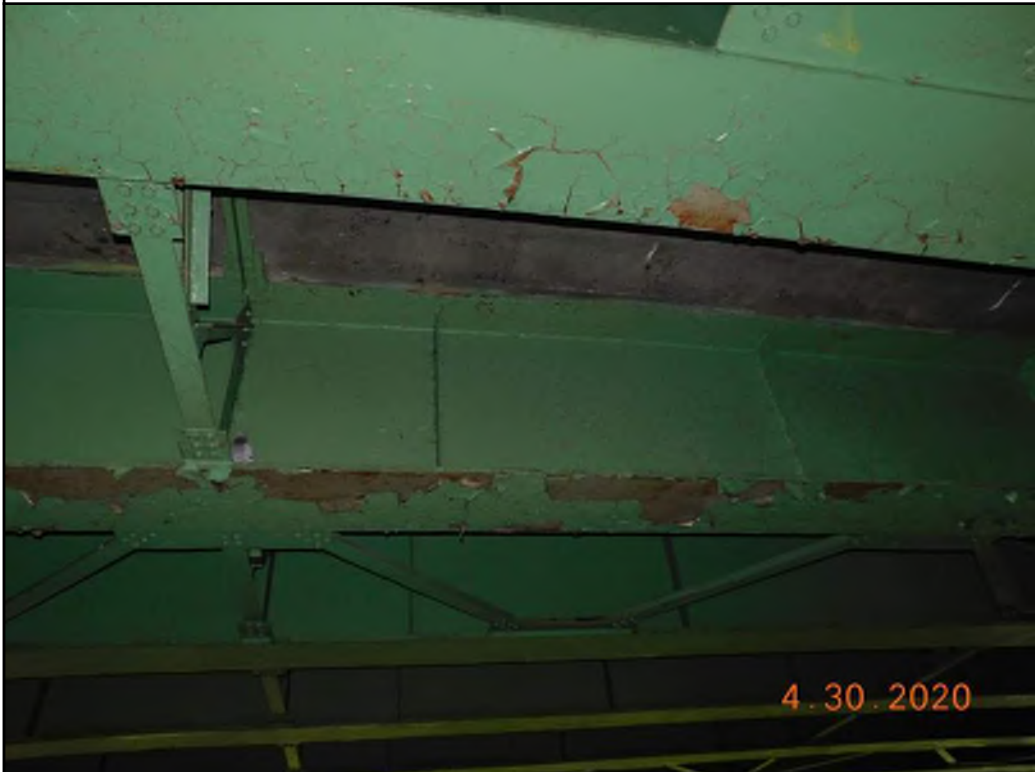
Photo Number: 52

Location: Span 14, Girder G7 & G8 near midspan; Looking Left. Area of cracked and peeling paint.

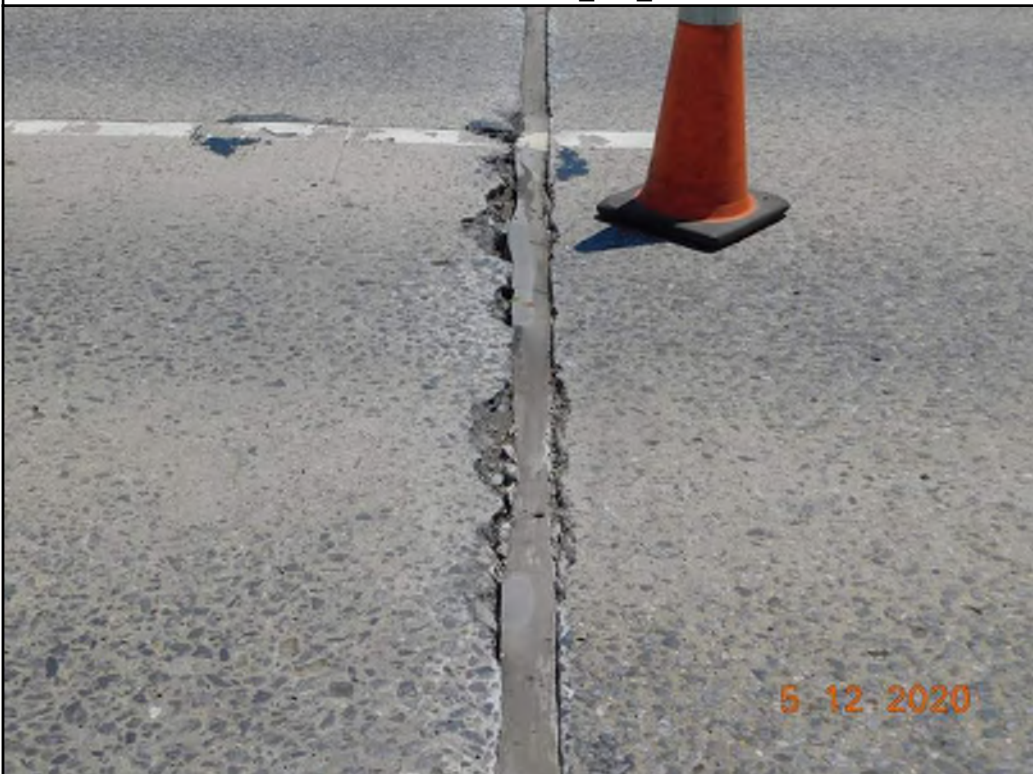
<p><b>Attachment Description:</b> Location: End Abutment Joint, E/B; Looking Right. Joint seal is deteriorated and debonded.</p>	<p>Photo Number: <b>54</b>      Photo Filename: <b>20_SW_6097.JPG</b></p>

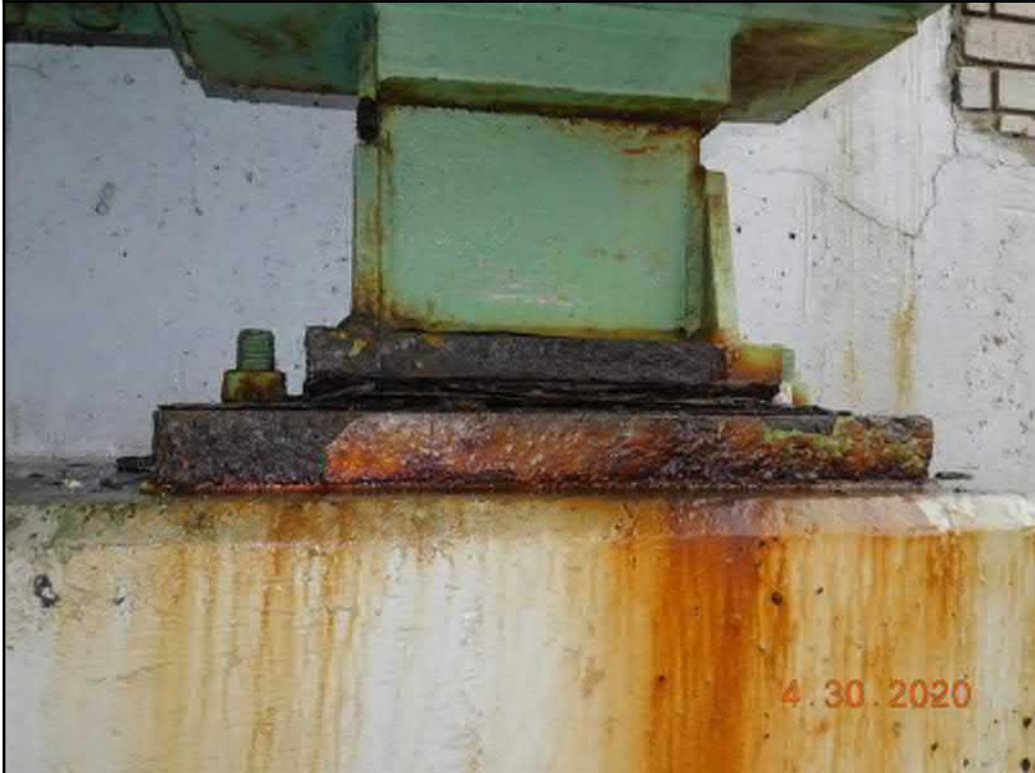
Photo Number: 55 Photo Filename: 20\_SW\_5854.JPG

Location: End Abutment, Bearing G17; Looking Ahead. Pack rust between rocker and masonry plate and deteriorated paint with surface corrosion.

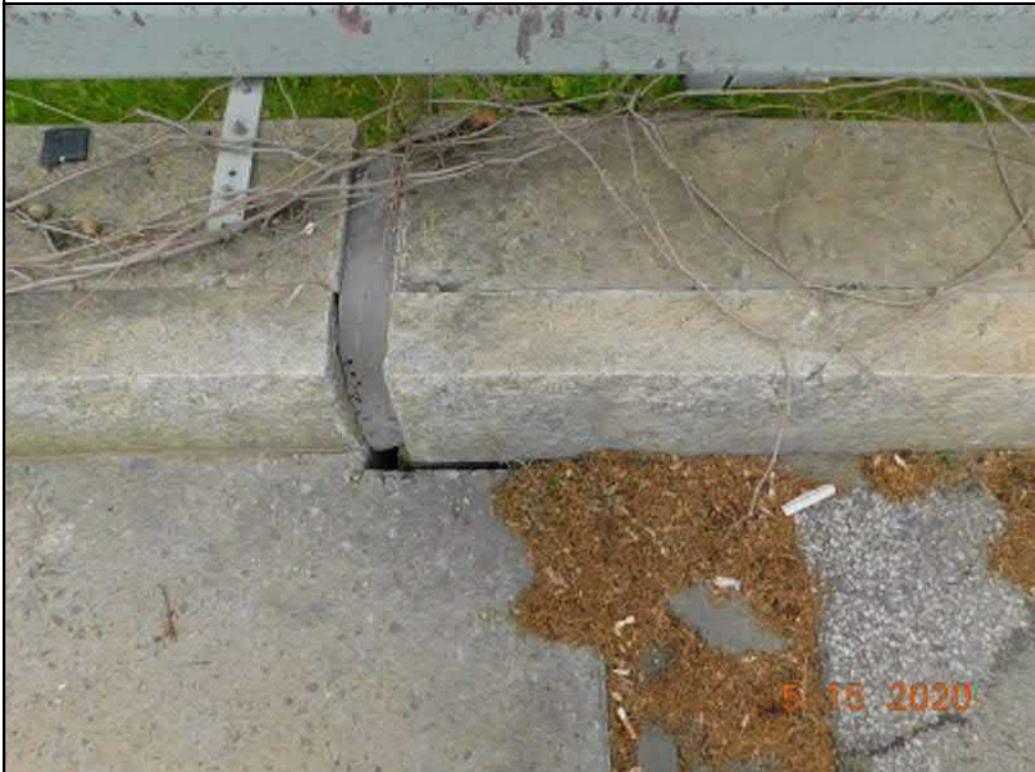
Photo Number: 56 Photo Filename: 20\_SW\_6138.JPG

Location: Span 15, Left Curb at End Abutment; Looking Down and Left. Gap between curb and concrete deck.

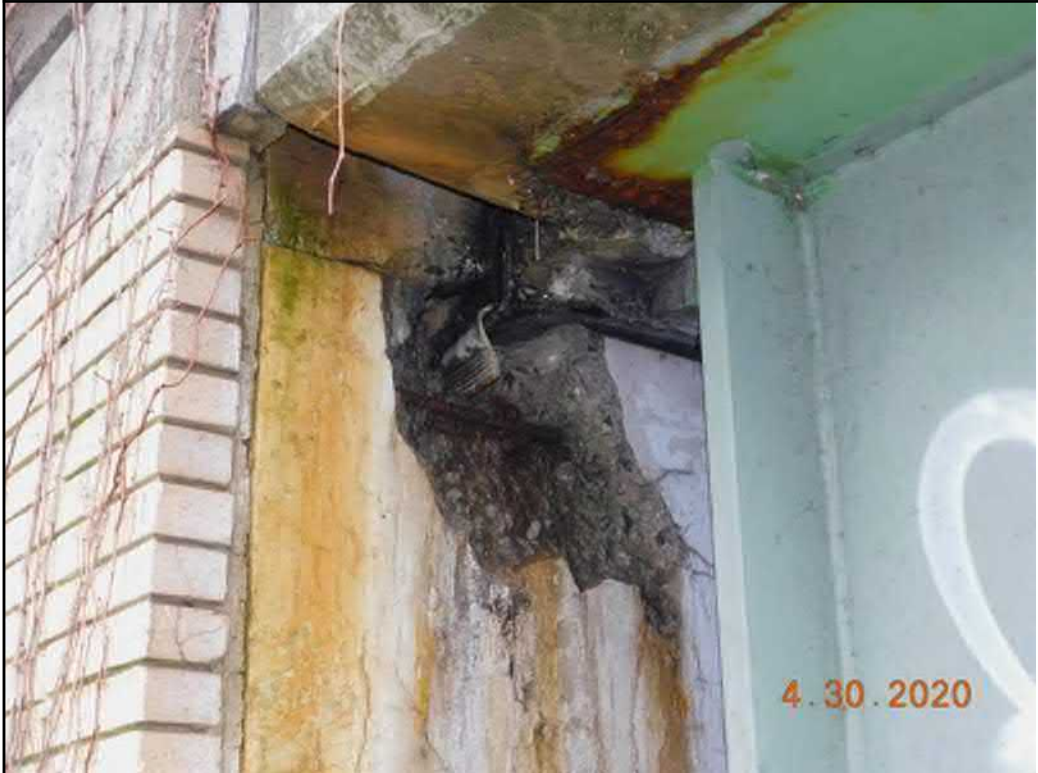
Photo Number: 57

**Attachment Description:**  
Location: End Abutment  
Backwall, Left Side; Looking  
Ahead. Spall with exposed  
rebar.

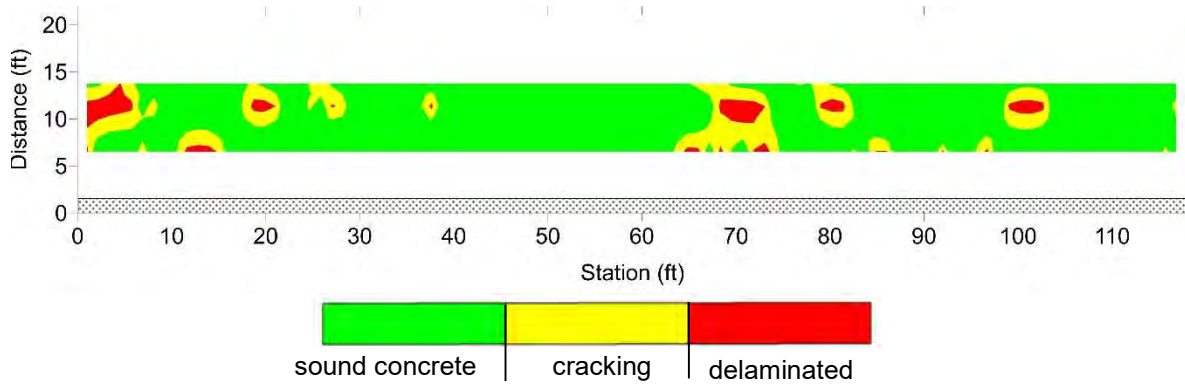
Figure 5: IE/PV Survey Map for Span 9 Eastbound Slow Lane

Figure 5 through Figure 7. For most of the spans, delaminated areas exceeded 30% of the tested area (Table 1). Span 9 EB was in the best condition with only 5% delaminated area (

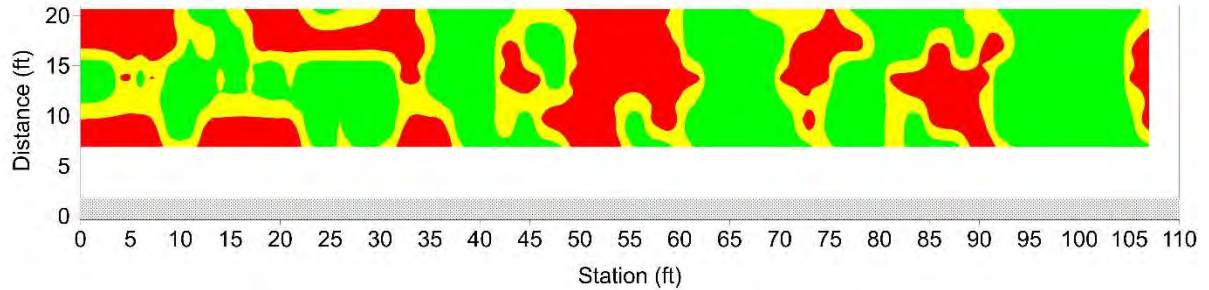
Figure 6: IE/PV Survey Map for Span 4 Westbound Slow Lane

Figure 5), and Span 12 WB was in the worst condition with 72% delaminated area (Figure 7). 72% of delaminations for an area is excessive, and IE/PV testing may be overestimating this value. However, it is clear that the concrete in Span 12 WB has extensive deterioration. Figure 6 shows an IE/PV survey map that is typical for the majority of the spans. Overall, 41% of the area was delaminated, 19% of the area indicated the presence of cracking, and 40% was sound (Table 1). It should be noted that in the areas of delaminations and subsurface horizontal cracking, IE/PV testing is not able to detect the condition of the deck below the delamination/crack as the signal is not able to penetrate the crack boundary.

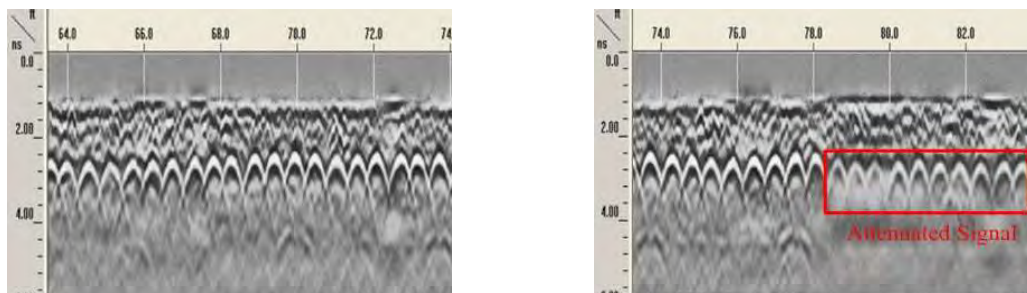
Figure 8: Attenuation of GPR Signal due to Deterioration of Concrete

Figure 8 provides an example of GPR data collected on a reinforced concrete slab. The distinct white hyperbolas are the reflections of the GPR signal by the embedded steel reinforcement. The stronger the reflection the greater the amplitude and the brighter white it appears. Areas of deterioration have a weaker reflection and thus appear darker and faded.

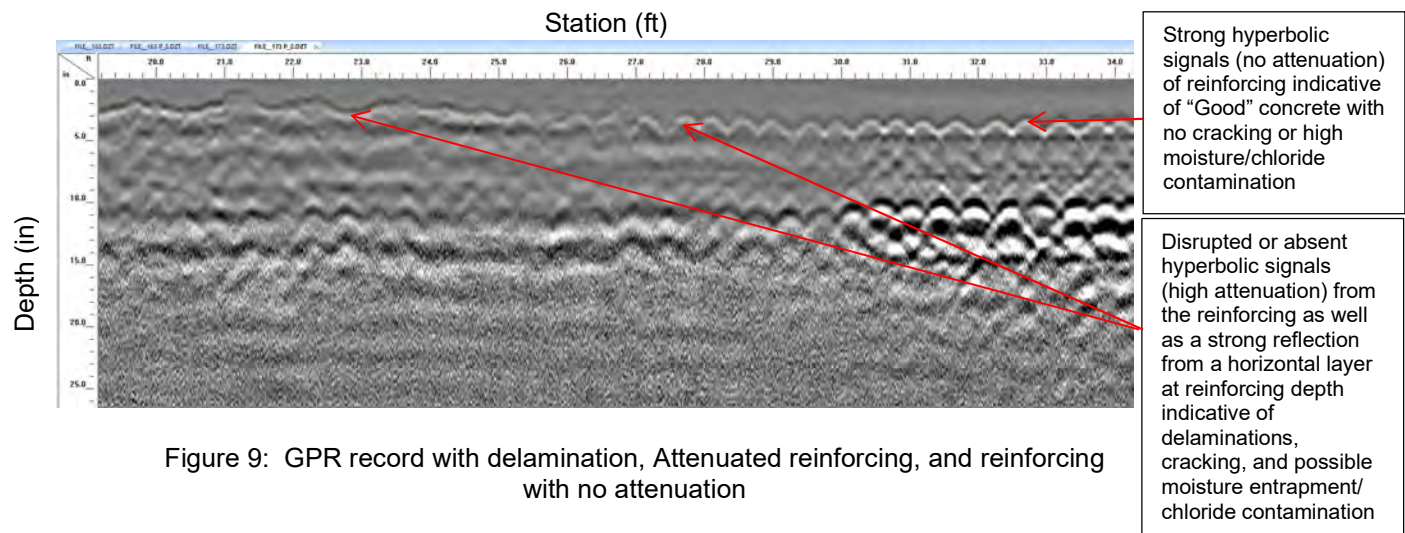
Figure 9: GPR record with delamination, Attenuated reinforcing, and reinforcing with no attenuation

An annotated GPR record from Span 5 EB is shown in Figure 9. A delamination was detected and is shown from station 19 to 26 as a horizontal band in the signal. The delamination's depth varied from 1 to 3 inches from the top surface of the concrete to the top reinforcing layer. This delamination is easily detected by hammer sounding. From station 26 to 30 is an example of an attenuated signal return from the reinforcing. Generally, this is indicative of an area of potential deterioration to the beginning of active deterioration. Hammer sounding will not detect this condition. The strong signal return from station 30 to 34 is indicative of an area with a low probability for deterioration.

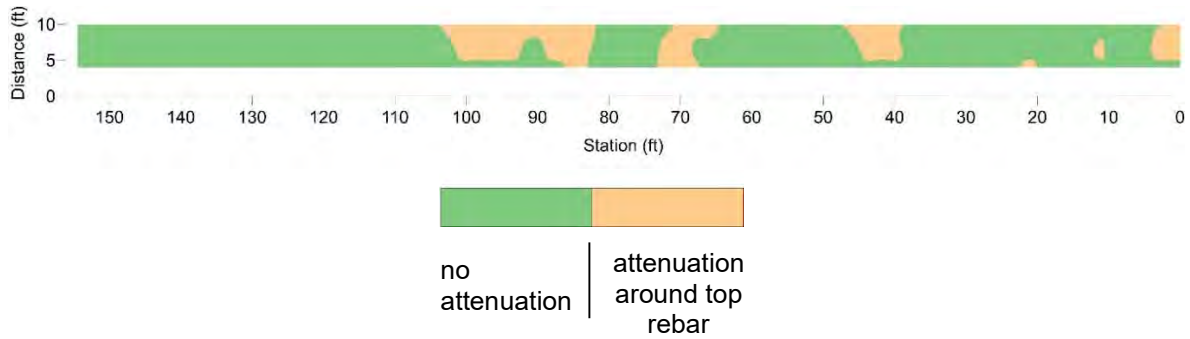
Figure 10: GPR Survey Map Ramp H

Figure 10 through Figure 12 show typical GPR survey maps, while the maps for all the tested areas are presented in Appendix C. Ramp H was generally in good condition with majority of the tested area showing no attenuation (Figure 10). Span 4 condition was generally typical for the majority of the spans (Figure 11), while Span 12 represents the worse condition (Figure 12). Statistical analysis of the results is presented in Table 2. Overall, 52% of the tested area had no attenuation and is considered to be in good condition, while attenuation around the top reinforcement was observed in 48% of the tested area. Comparing the IE/PV data with the GPR data shows that the results obtained by these testing methods are very similar.

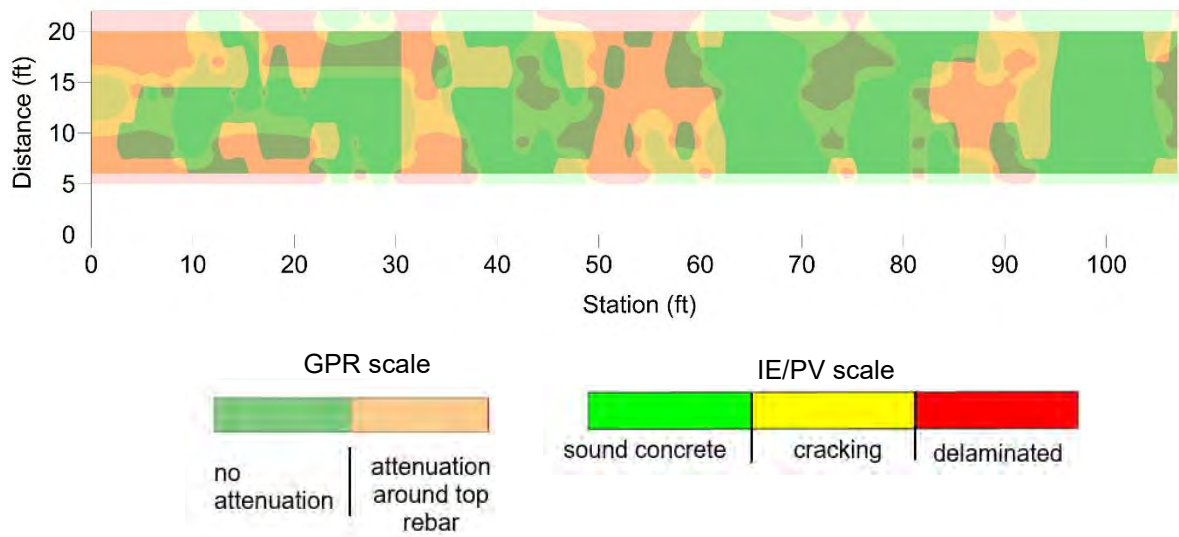
Figure 13: IE/PV Survey Map Overlaid on Top of the GPR Survey Map for Span 4 WB

Figure 13 shows the IE/PV map overlaid on top of the GPR survey map for Span 4. Sound areas indicated by IE/PV testing generally corresponded to the areas of no attenuation in

the GPR scans. This indicates that a large number of the areas where signal attenuation was observed in the GPR scans correspond to the areas of cracking and delaminations identified by the IE/PV testing. GPR signal attenuation in areas of sound concrete is most likely due to moisture or high chloride concentrations.

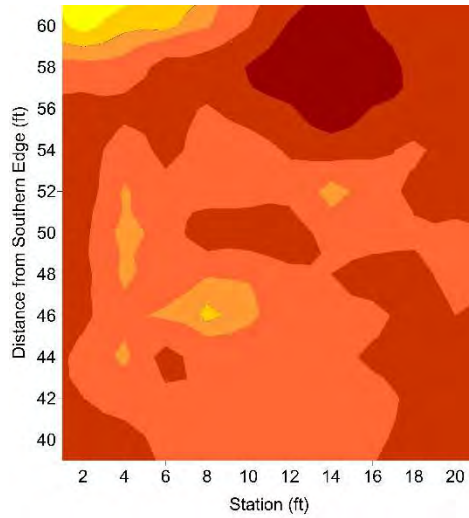
Figure 15: Corrosion Potential Survey of Span 3 EB

Figure 15 through Figure 17 show typical corrosion potential survey maps. The maps for all the tested areas are included in Appendix D. Generally, reinforcement corrosion was wide-spread. Majority (81%) of the area was at 90% probability of active corrosion, 16% was in the uncertain range and 15% was at 90% probability of passive steel (Table 4).

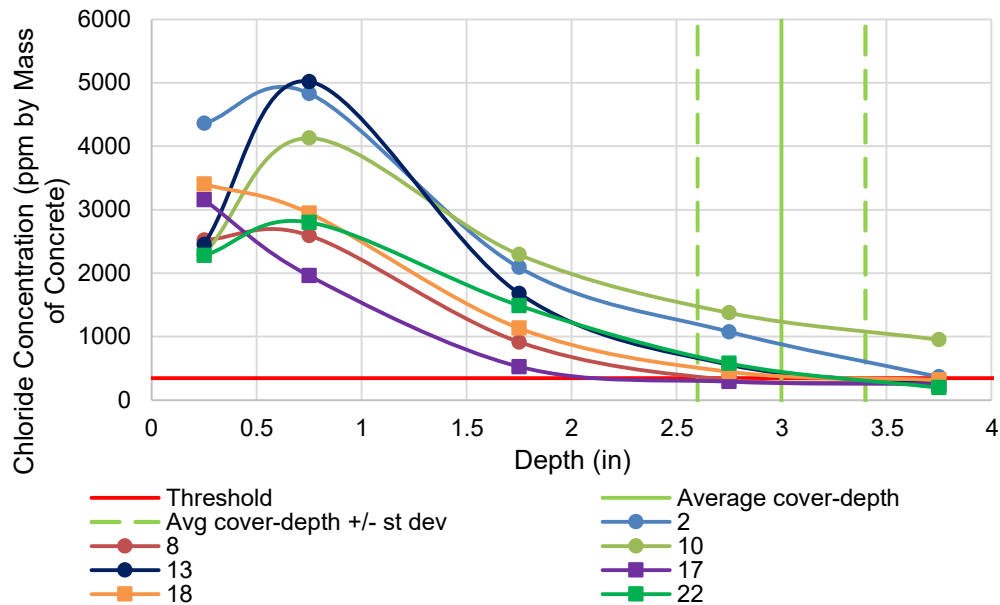
Figure 18: Chloride Concentration Profiles from the Extracted Cores

Figure 18 shows the chloride profiles for all the collected samples. The average reinforcement cover-depth and the average plus/minus one standard deviation are indicated in the plot by vertical green lines, and the chloride threshold value of 350 ppm is plotted as a horizontal red line.

Chloride concentration at rebar depth was above the corrosion initiation threshold of 350 ppm for all the samples, except for cores 8 and 17 where the chloride concentration was at the lower bound of the threshold (300 ppm). This indicates high risk for chloride-induced corrosion of the top reinforcement mat throughout the deck.

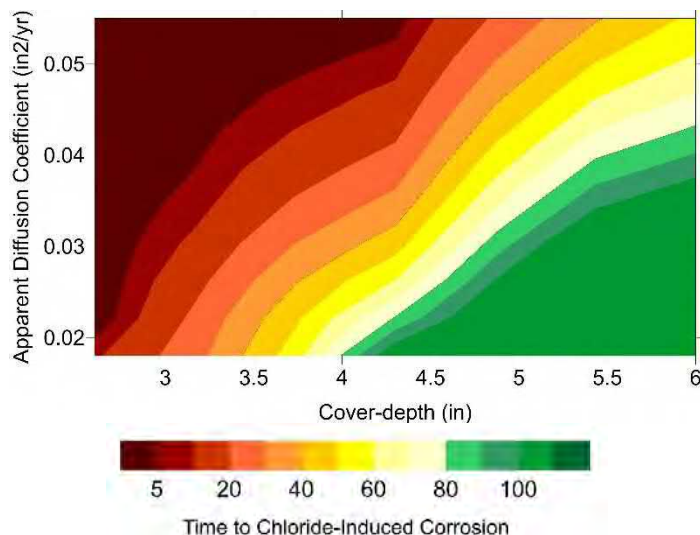
Figure 20: Projected Time to the End of the Initiation Period for the Deck from the Date of Inspection (Year 2021)

As can be seen in Figure 20, reinforcement with cover-depths of up to 3 inches has already reached the end of the initiation period for the average value of  $D_c$ . At high values of  $D_c$ , reinforcement with cover-depths up to 4 inches has also reached the end of the initiation period. It should be noted that the model in Figure 20 only applies to areas of sound concrete. Sub-vertical cracks in the top of the deck would provide a direct path for chlorides into the concrete cross-section, which will significantly reduce the expected service life of the bottom reinforcement mat.

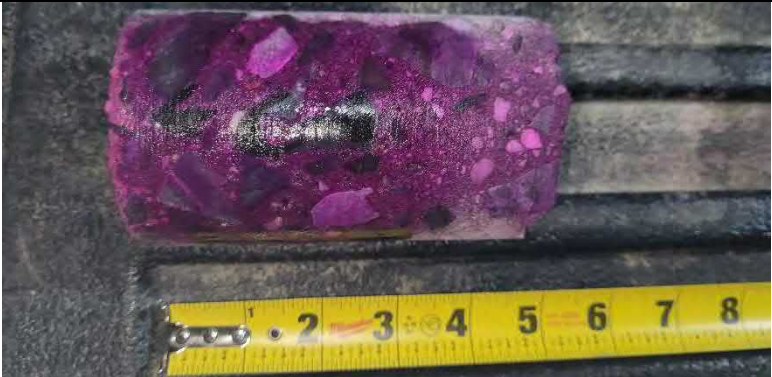
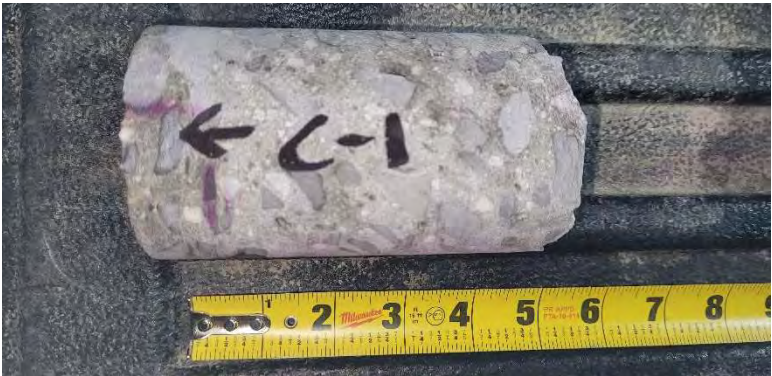
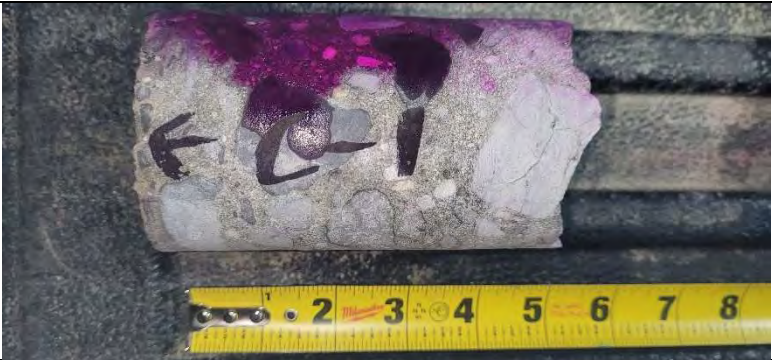
Core 1

Side C		
Length: 4.75"	0" Carbonation	Location: Eastbound - Slow Lane West Approach Slab 8' North from South Curb 27.5' West of West Abutment

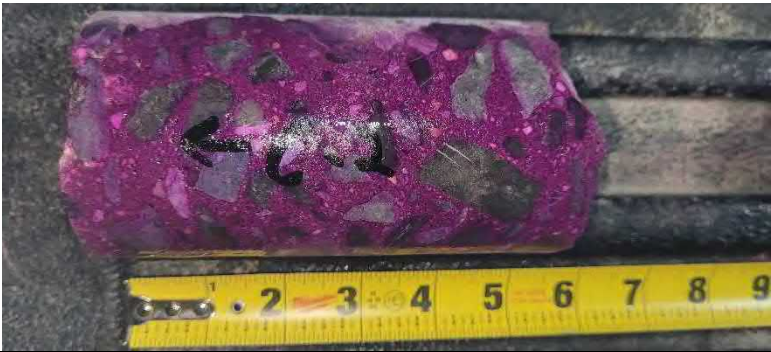
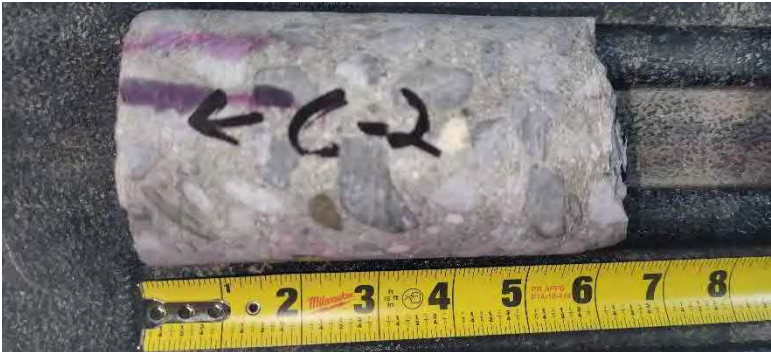
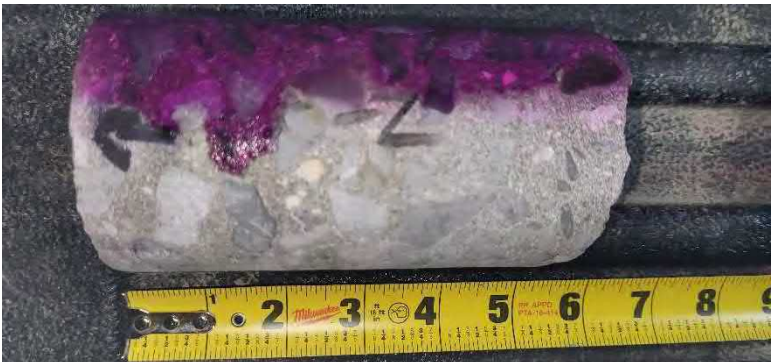
Core 2

Side C		
Length: 5.5"	0" Carbonation	Location: Eastbound - Slow Lane Span 1 13.5' North from South Curb 59.5' East of West Abutment

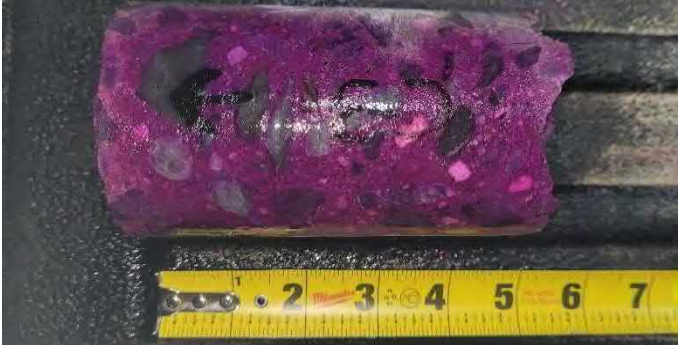
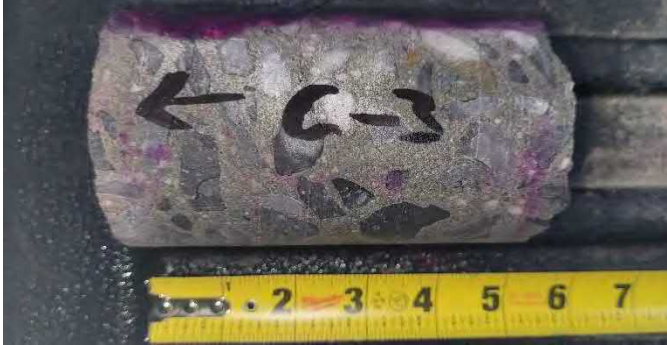
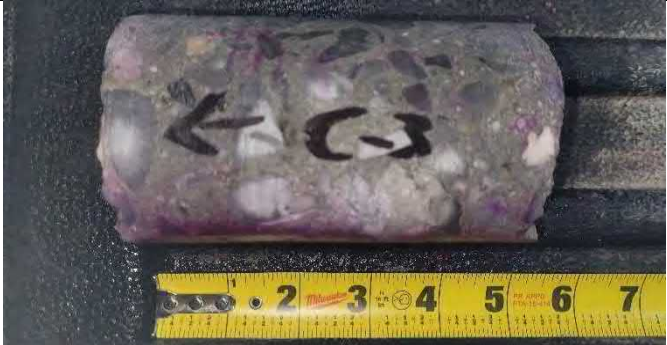
Core 3

Side C		
Length: 4.75"	0" Carbonation	Location: Eastbound - Slow Lane Span 3 24' North from South Curb 50.5' West of Pier 3

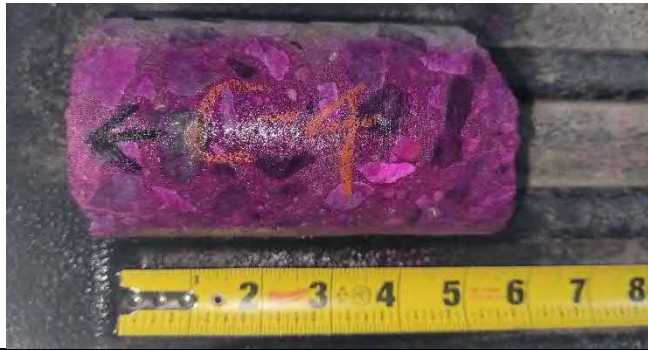
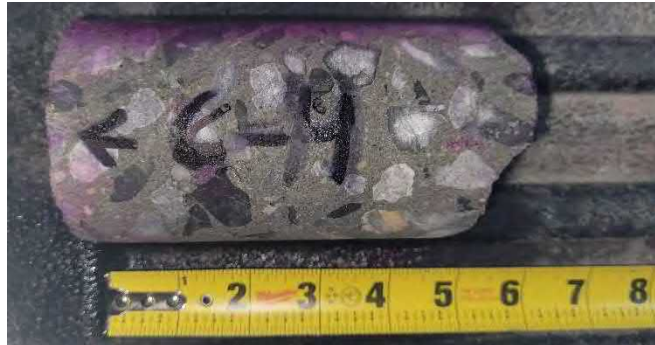
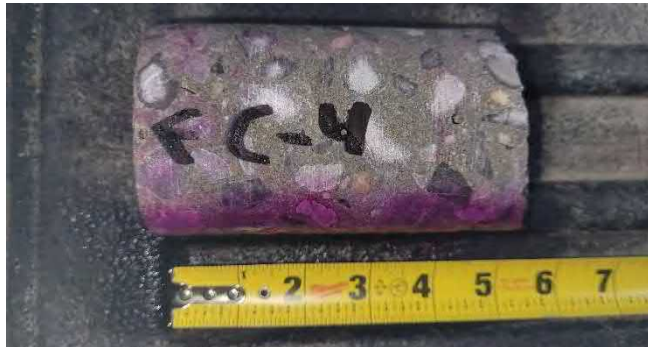
**Core 4**

Length: 5"	0" Carbonation	Location: Eastbound - Slow Lane Span 5 13' North from South Curb 33' West of Pier 5
------------	----------------	---
